Manhole Inspection Summary

Manhole # S2500_016MH

Insp Date: **7/26/07 9:06 AM**

Location Address: **927 BROOKS LN**

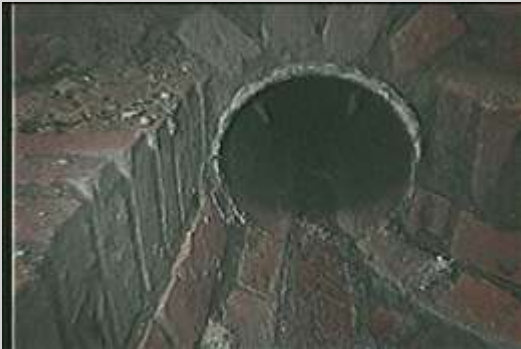
Pipe Out @ 12 O'Clock

8 in. Circular Gravity Sewer

Pipe Material: **Clay** ☐ Pipe Lined

Invert Depth: **7.00** (ft.) Flow Characteristics: **Slow**

Deposits: ☒ None ☐ Mud ☐ Sludge ☐ Debris ☐ Grease

Infiltration: **None** Pipe Seal Cond: **Unknown**

Drop: **None**

Connects To: **Manhole**

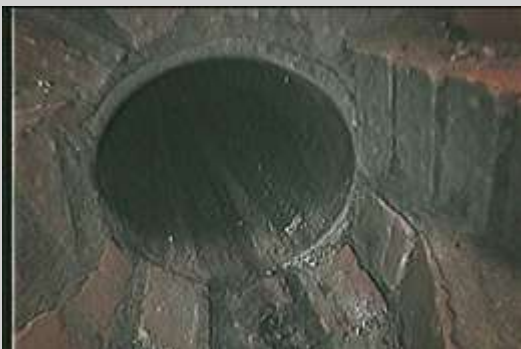
Pipe In @ 2 O'Clock

8 in. Circular Gravity Sewer

Pipe Material: **Clay** ☐ Pipe Lined

Infiltration: **None** Pipe Seal Cond: **Unknown**
